## Structural Health Monitoring – Case Story

**Structure:** Bridge

**Measurement:** Displacement (seat/abutment)

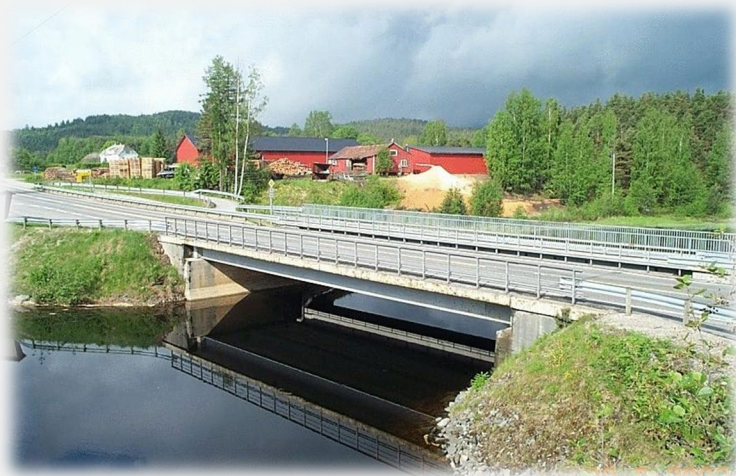
**Purpose:** Monitoring bridge displacement at varying temperatures to foresee cracks generation and perform general diagnosis

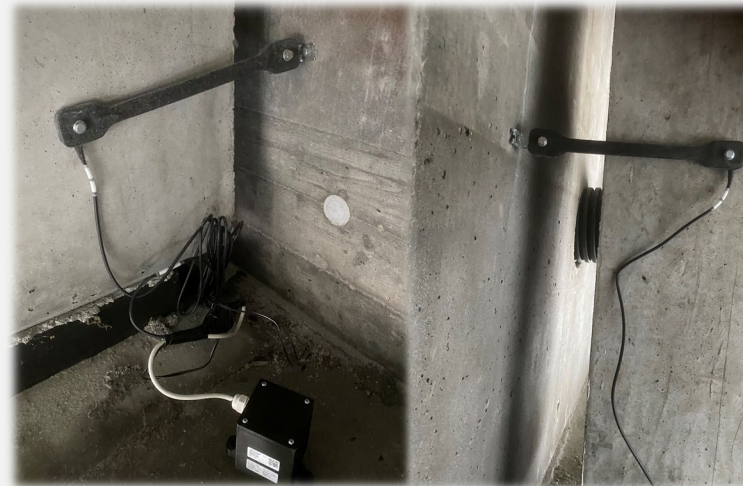
**Sensors:** 2x DS100 sensors were installed at either end of the bridge between abutment and seat to measure relative displacements

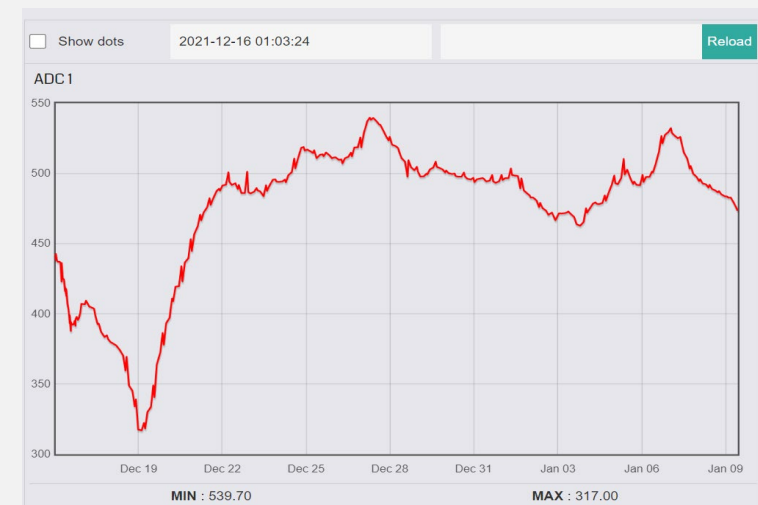
**Data interpretation:** Each unit at Y-Axis corresponds to 76 $\mu$ m relative displacement between abutment and seat of the bridge

**Live data:** Click [HERE](#) (Sensors 783 and 786)
